The Fire Resistance
Performance Of Two
Single-Leaf Timber
Doorsets, When Tested In
Accordance With BS EN
1634-1:2014 + A1:2018

01 October 2019

415117

Gianni Industries Inc

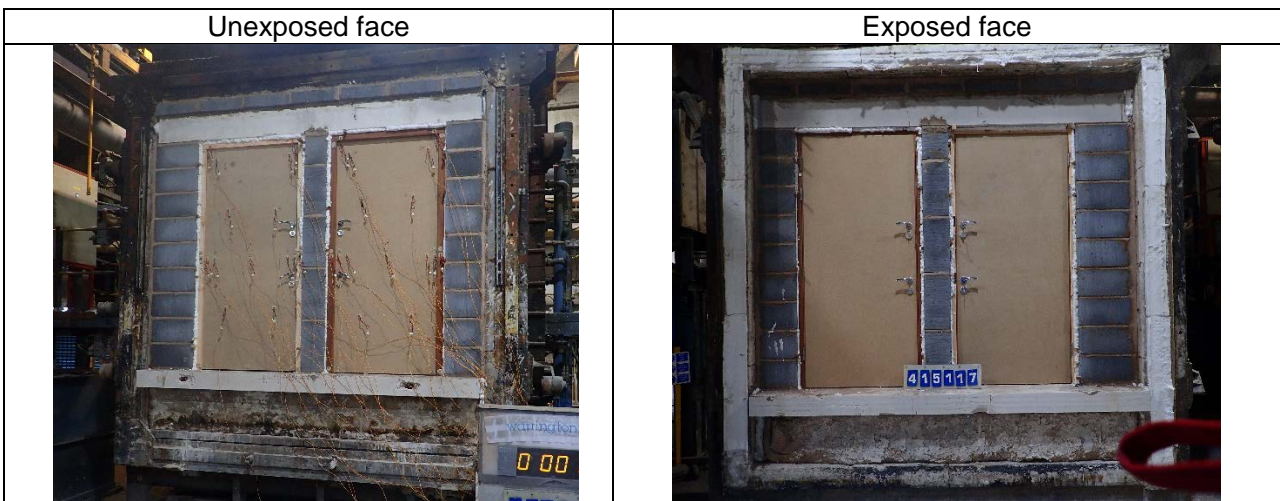
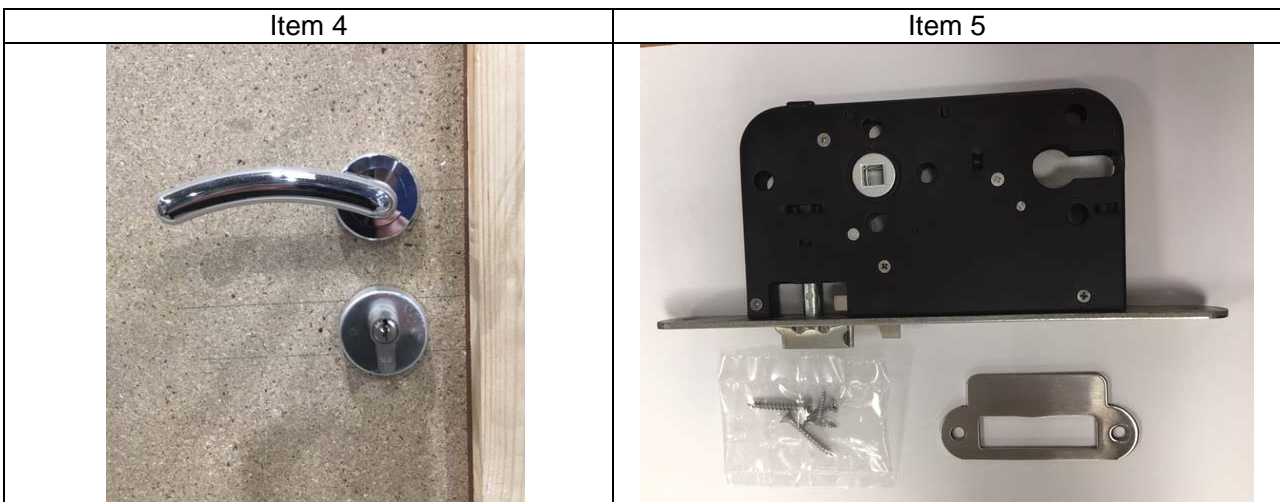
Figure 10 – Photos of ironmongery

Lever Handleset

Latch

i. Lever handle	: Polished Chrome
ii. Backplate	: Polished Chrome
Overall size	
iii. Lever handle	: 120mm long x 18mm dia x 60mm protrusion
iv. Backplate	: 50mm dia x 10mm thick
Fixing method	: Screw fixed to doorleaf 'A+B'
Escutcheon	
Manufacturer	: Smith and Locke
Reference	: SKU-6917SKU/ Euro Escutcheon
Material	: Satin Aluminium with plastic inlay
Overall size	: 53mm dia x 11mm thick
Fixing method	: Screw fixed to doorleaf 'A+B'

5. Latch	
Manufacturer	: Securefast plc
Reference	: SEU777/2R
Material	
i. Lock case	: Steel
ii. Forend plate	: Steel
iii. Latch bolt	: Steel
iv. Mini latch bolt	: Steel
Overall sizes

i. Lock case	: 155mm long x 75mm wide x 15.5mm deep
ii. Forend plate	: 235mm long x 24mm wide x 3mm thick
iii. Latch bolt	: 32mm long x 12mm wide x 11mm projection
iv. Mini bolt	: 8mm long x 10mm wide & 8mm projection
Fixing Method	: Screw fixed
Operation of Latch bolt (upper lockset)	: Engaged
Operation of Latch bolt (lower lockset)	: Disengaged
Bedding material	: The lockcase and behind the forend plate was wrapped in 1mm interdens on both doorsets

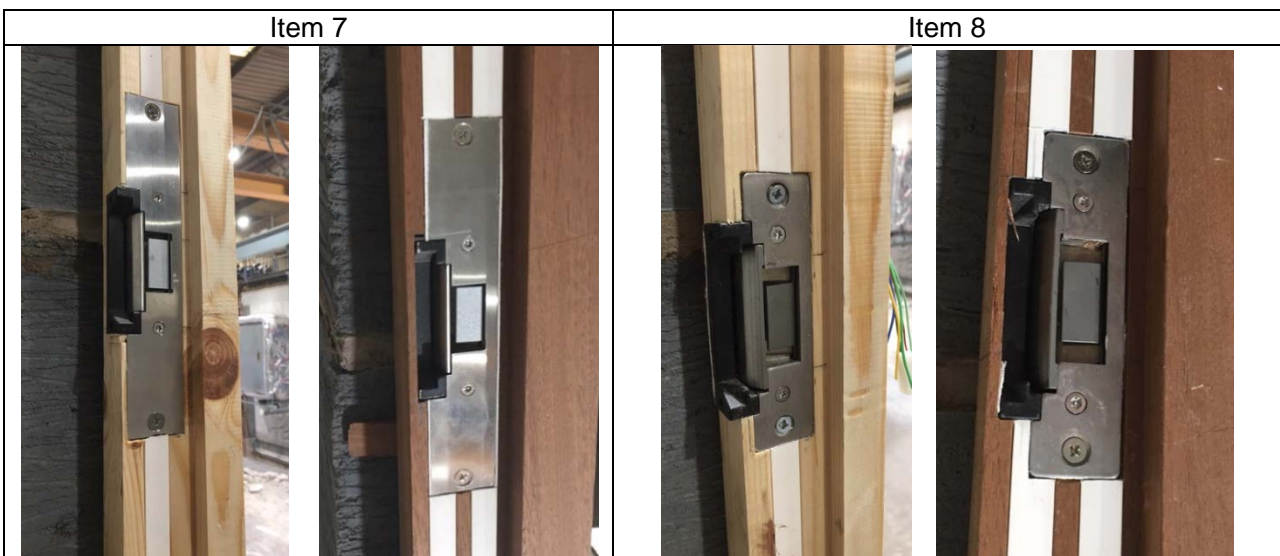
Strike (fail secure) / showing intumescent interruption

Strike (fail safe) / showing intumescent interruption

<u>Item</u>	<u>Description</u>
7. Strike Plate – Fail Secure	
Manufacturer	: Gianni Industries Inc
Reference	: GK361M-ST-1224
Primary material	: Stainless Steel
Overall sizes	: 201.6mm Long x 43mm Wide x 29.5mm Deep
Bedding material	: Wrapped in 1mm interdens on both doorsets

8. Strike Plate – Fail Safe	
Manufacturer	: Gianni Industries Inc
Reference	: GK450M-ST-1224
Primary material	: Stainless Steel
Overall sizes	: 123.8mm Long x 31.8 -43.5mm Wide x 29.5mm Deep
Bedding material	: Wrapped in 1mm interdens on both doorsets

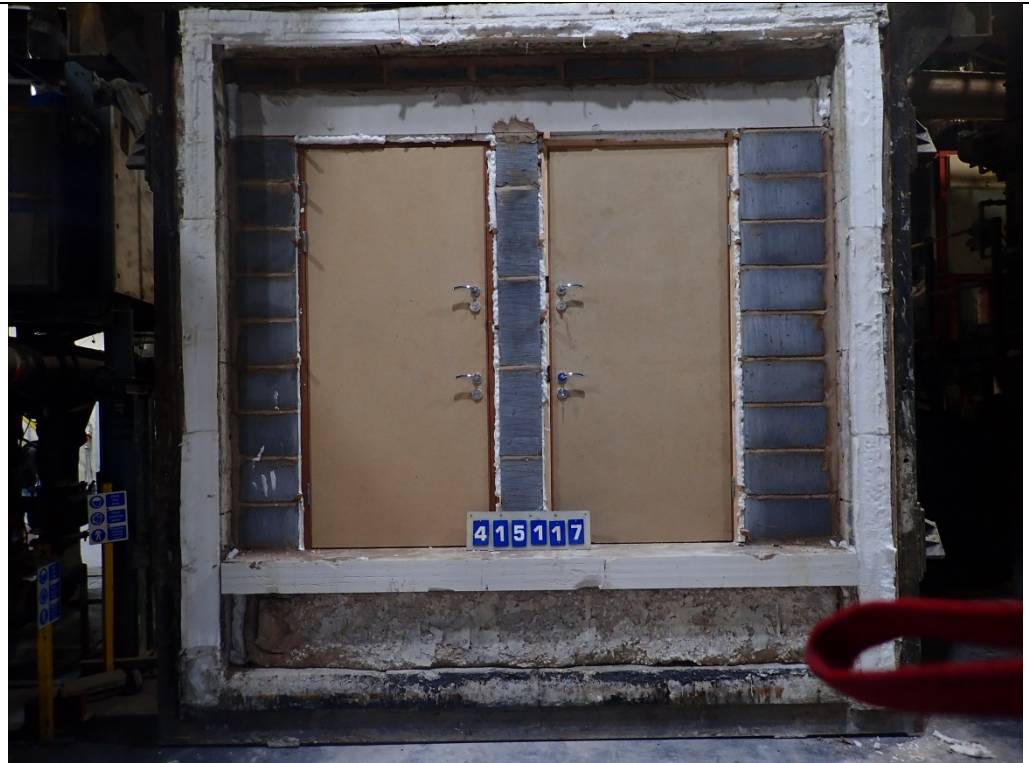
The exposed face of the doorsets prior to the start of the test

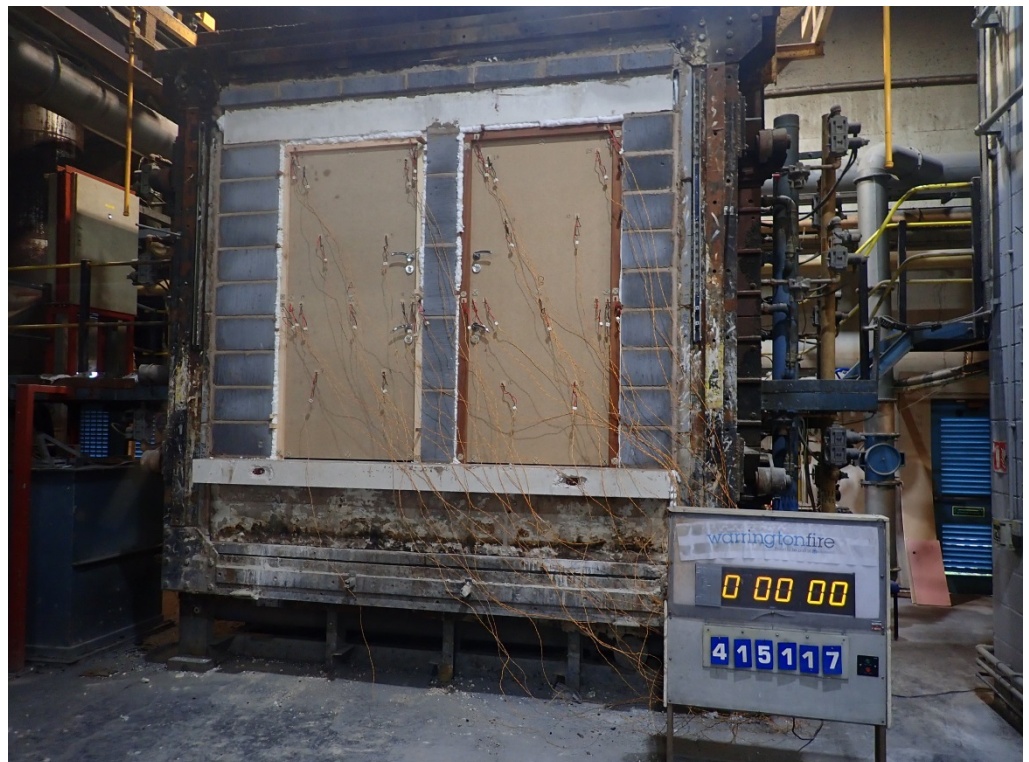
The unexposed face of the doorsets prior to the start of the test

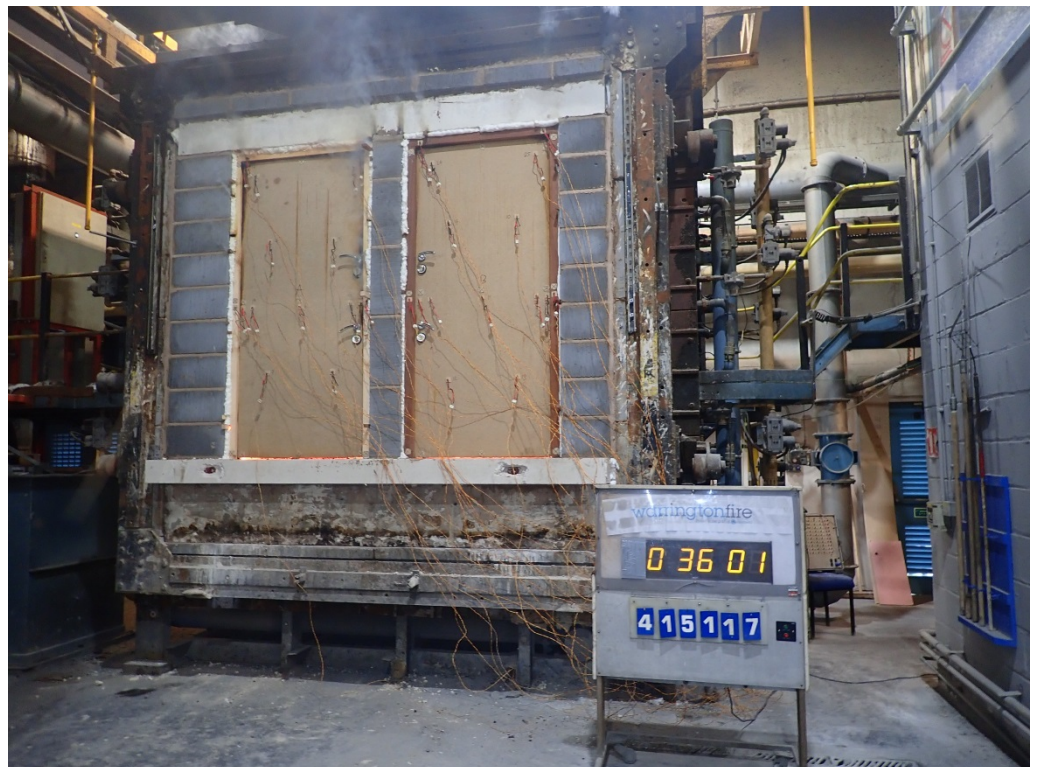
The unexposed face of the doorsets after a test duration of 36 minutes

Specimen	36 minutes	No failure*	63 minutes	Due to integrity failure
Insulation (I₁)	The test specimen shall be evaluated against the maximum temperature rise criterion specified in EN 1363-1 (180°C).			
	36 minutes*		63 minutes	
*Test was discontinued after a period of 68 minutes. Doorset A was blanked off after a period of 36 minutes to allow the test to continue.

24	40	Steam/smoke release coming from all of the cylinders and around the roses on both Doorsets.
25	00	Flicker of flame coming from the lower strike plate position on Doorset A.
27	45	Cotton pad applied at the lower lockset on Doorset A, no discolouration of the cotton pad.
28	45	The plastic insert on the escutcheons can be seen to be reacting.
29	13	Flicker of flame at the lower lockset on Doorset A.
30	50	Cotton pad applied at the lower lockset on Doorset A, no discolouration of the cotton pad.
33	28	Flicker of flame at the lower lockset position on Doorset A.
34	29	Door leaf A can be seen to have bowed away from the heating conditions.
35	45	Flickers of flame at the lower lockset on Doorset A.
36	10	No sustained flaming on Doorset A, Doorset A is dampened down with water and blanked off to allow the test to continue.

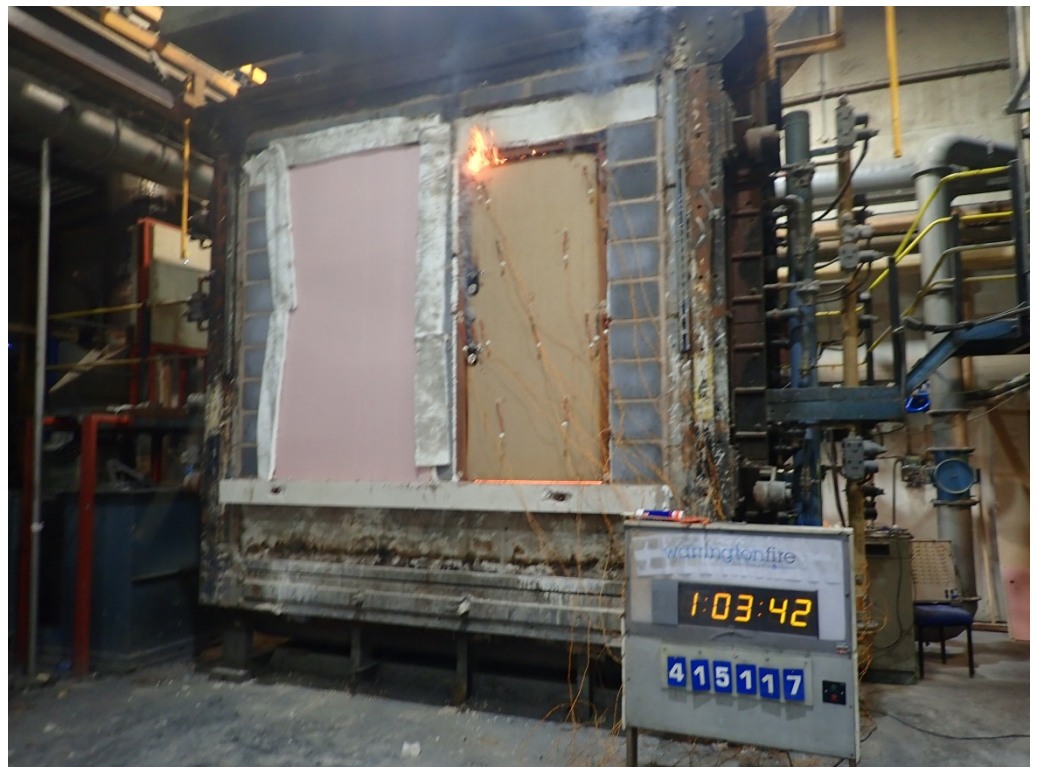
The unexposed face of Doorset B after a test duration of 63 minutes

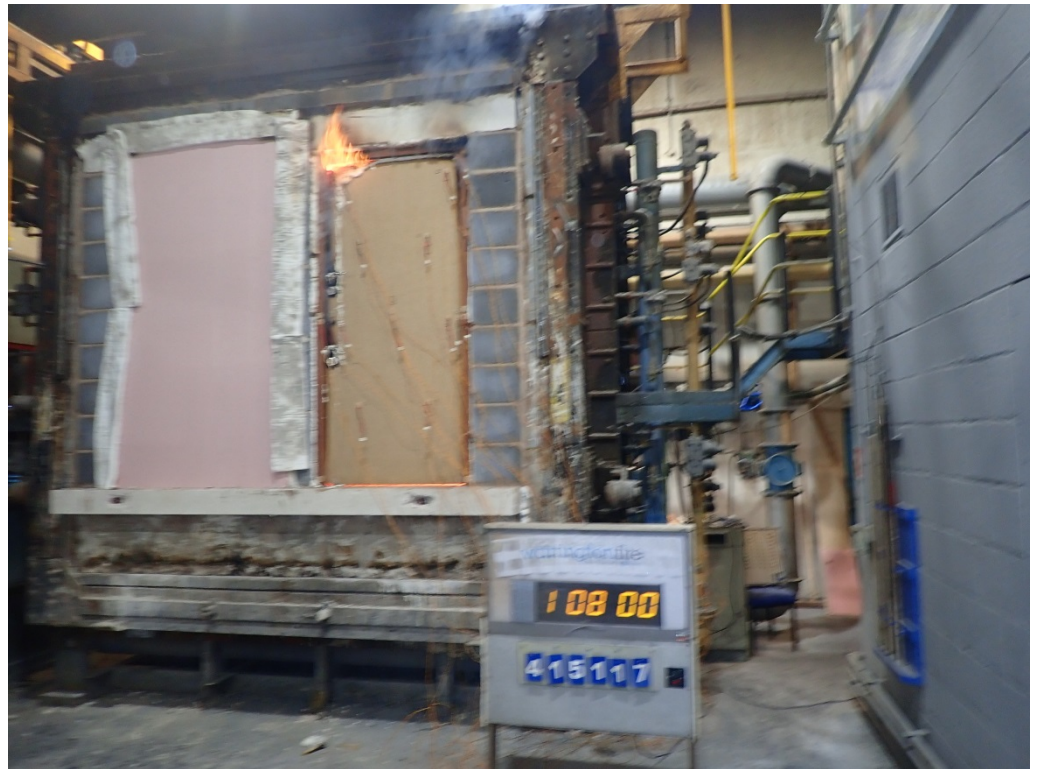
The unexposed face of Doorset B after a test duration of 68 minutes

42	14	The cylinders on Doorset B are now discolouring a golden brown colour.
48	07	The plastic insert on the escutcheons is starting to melt.
54	40	Black discolouration at the lockset positions and the top hinge position on Doorset B.
57	55	Flicker of flame at the base of Doorset B. When viewed from the exposed face both handles and escutcheons have come away from the door leaf.
60	00	Continued black discolouration at the top latched and hinged corners and around the locksets on Doorset B.
63	37	Sustained flaming all along the head of Doorset B. Integrity failure is deemed to have occurred. The flaming is put out with water and sealed with intumescent mastic.
65	00	Glowing can be seen at the strike plate position of the upper lockset on Doorset B.
66	00	Glowing can be seen at the top hinge position on Doorset B.
68	10	Test discontinued.

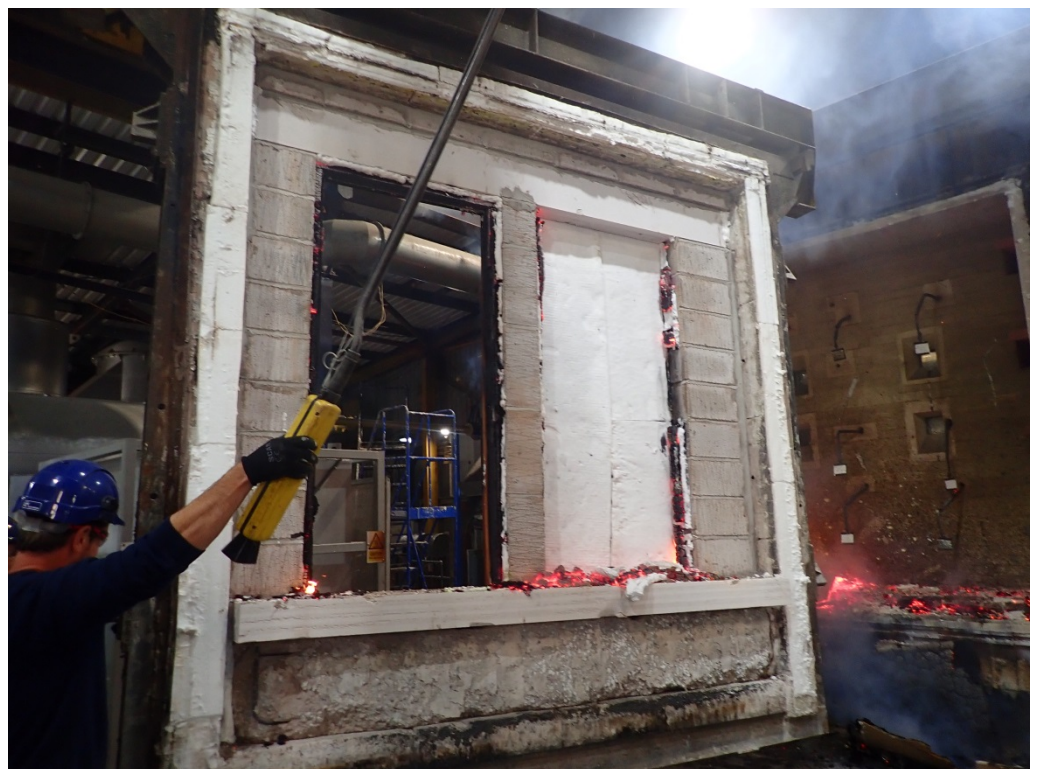
The exposed face of the test assembly shortly after the test
